**Cold Regions Research  
and Engineering Laboratory**

**ERDC/CRREL TR-03-11**

**US Army Corps  
of Engineers®**  
Engineer Research and  
Development Center

## **Remote Assessment of Army Tactical River Crossing Sites Using LIDAR Imagery**

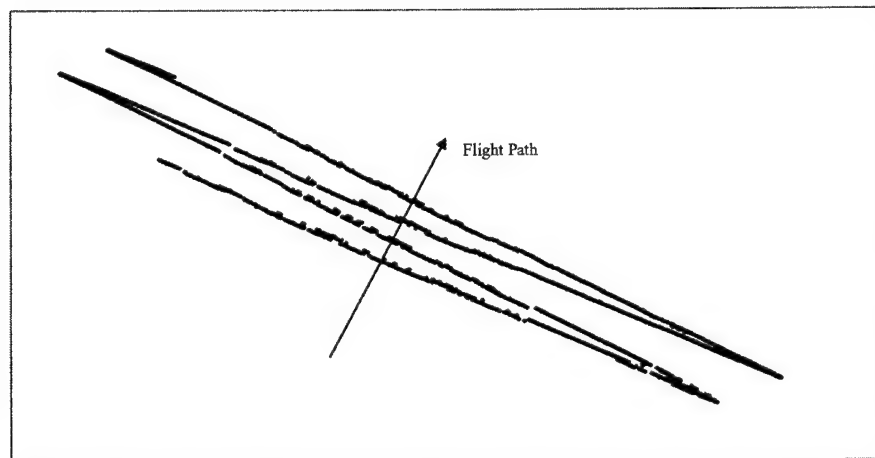
Figure 1. Example of a data scan line with a nutating mirror LIDAR. Each line consists of individual laser points that have an x, y, and z coordinate, as well as a light intensity value.

The UFL system is flown in a small fixed-wing aircraft between about 1000 and 6500 feet above ground level (AGL) with the laser light projected to the ground through a mirror that nutates perpendicular to the track of the aircraft. This results in a sawtooth point collection pattern as shown in Figure 1.

The laser's position in space is known at every instant using a kinematic Global Positioning System (GPS) and thus every point's location can be referenced to a known datum of the user's choosing. The point spacing is relatively dense in the axis of the mirror nutation but the forward motion of the plane causes gaps between the scan lines as the mirror traverses from one end of its travel to the other. As Figure 1 shows, the sawtooth pattern can affect how data should be collected to capture certain features.

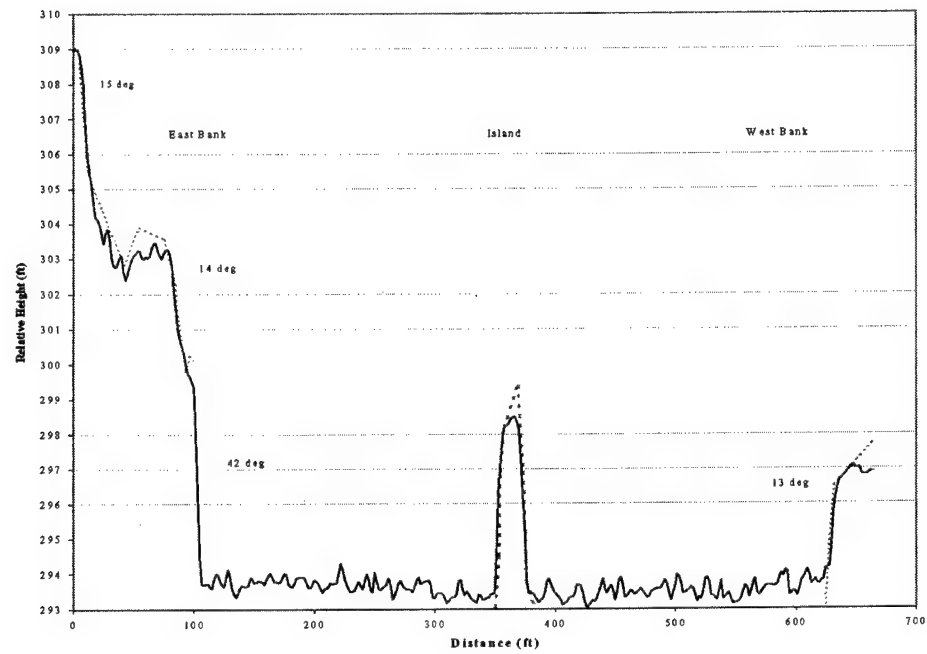
**Figure 3. Ground survey and LIDAR DEM comparison, Transect 1. This transect projects through the small island shown in Figure 2 above.**

The west bank at Site 1 was a low slope with leafy brush, tall grass, and a few widely spaced small trees. The LIDAR and ground surveys agree generally to less than 0.5-ft difference on this bank in all three transects. The east bank is steeper and more difficult to match. In the first two transects the two survey heights agree to generally within a foot, with some difference in the horizontal spacing. The third transect shows that the height of the small secondary bump near the water on the east bank disagrees between the surveys by about a three-foot height difference and a fifteen-foot horizontal difference. These differences could be as much a problem with our ground survey GPS positions as with possible LIDAR height differences. The profiles from the two systems are very similar and either represents the actual bank profiles.

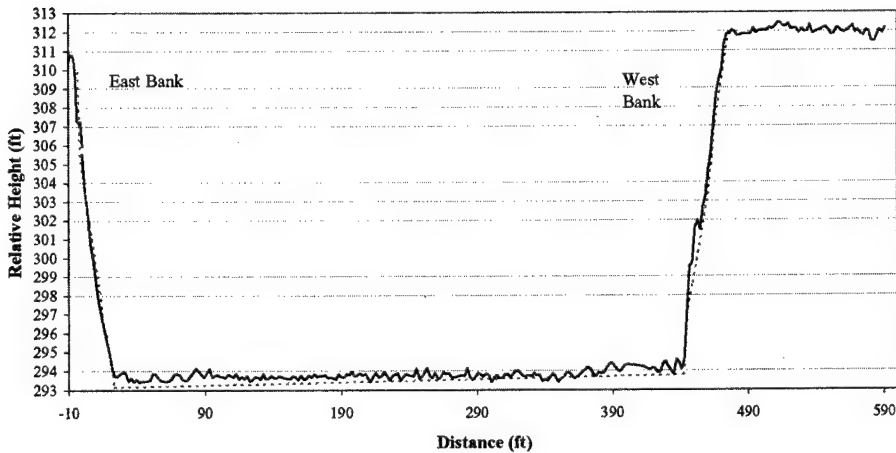
Figure 8. Ground survey and LIDAR DEM comparison, Site 2.

At this site the ground survey and DEM matched well, as shown in Figure 8.

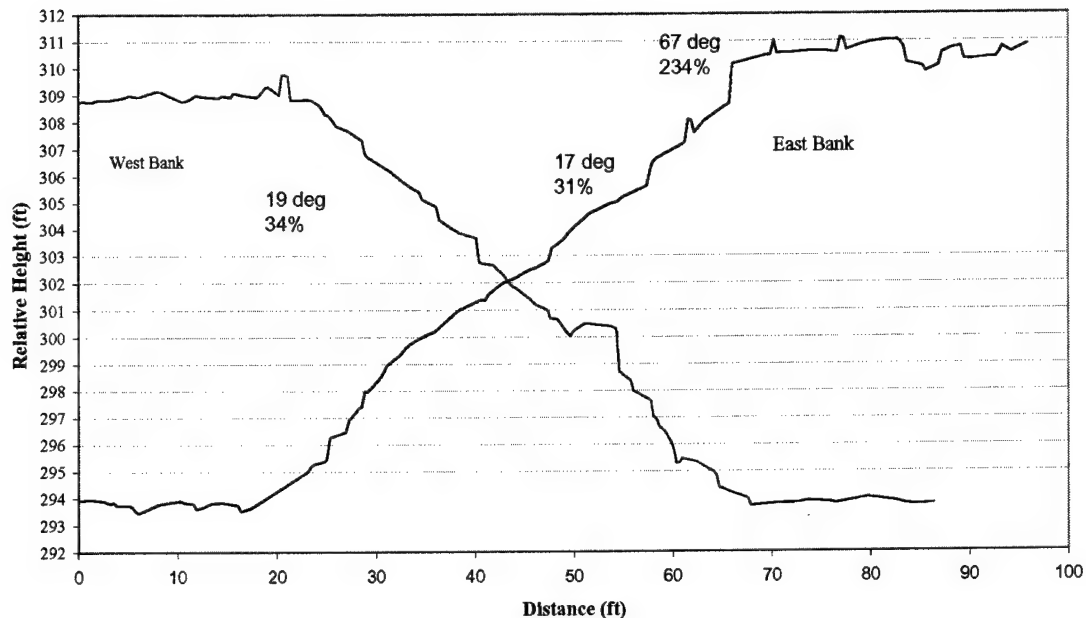
Figure 9. Site 2 bank slopes taken from the LIDAR data.

Figure 9 shows a close-up of just the bank slope data taken from the LIDAR DEM. Both banks are superimposed on each other in the graph.

At the top of the east bank is a short section of bank about 1.5 feet high at 67°. It was felt that this section on an already steep slope would be difficult, if not impossible, to traverse and was the reason for classifying this crossing as marginal. The on-site inspection found that the slope of this section actually approached 90° with the steep section being about 2 feet high and therefore not trafficable. The discrepancy of the DEM profile at the near-90° section seems characteristic of the technique and is illustrated further below. Figure 10 shows the DEM from Site 20.

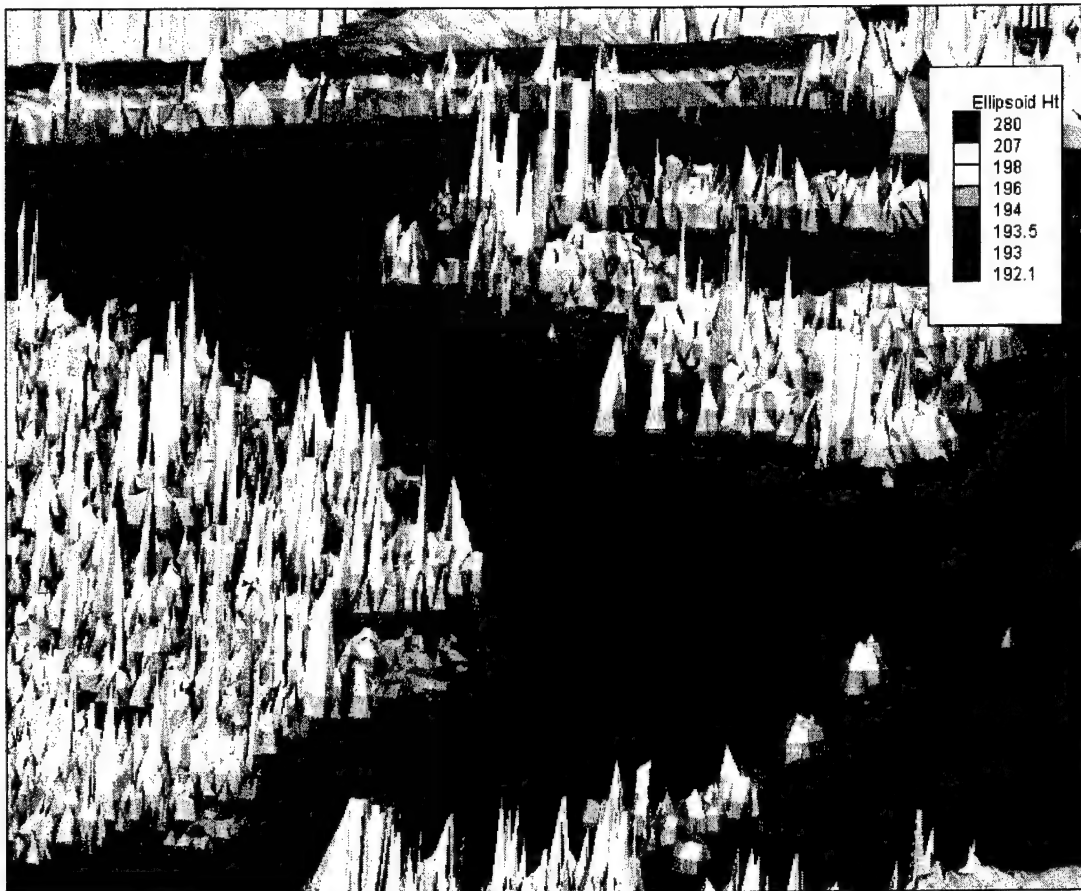
**Figure 10. Site 20 LIDAR DEM looking south. The transect shown goes from right (west) to left (east) in this figure, starting in the open area on the right.**

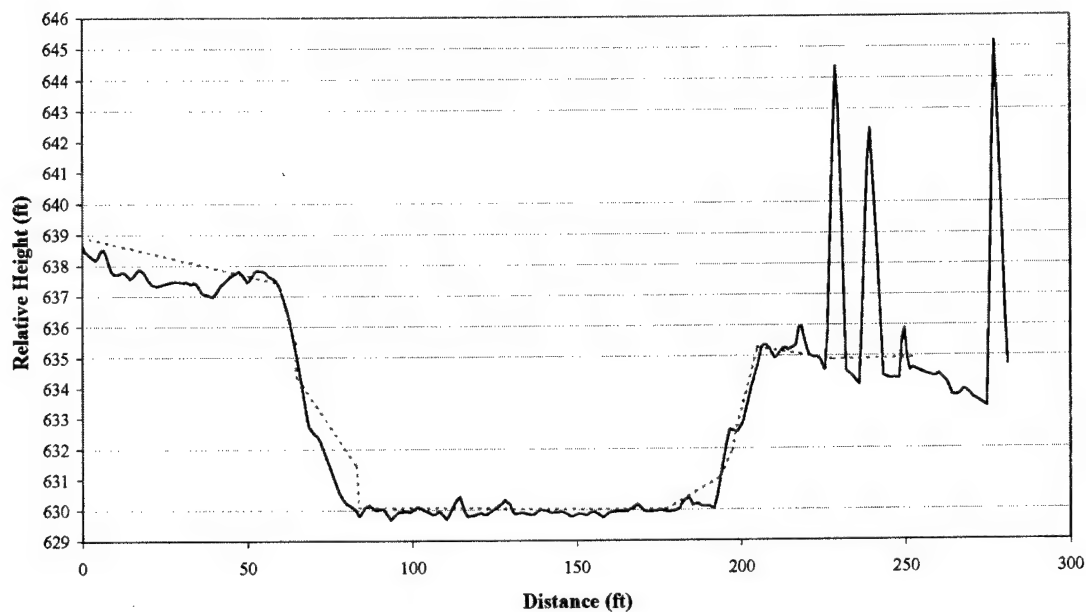
**Figure 11. Site 20 LIDAR and ground survey comparison profile from west to east. The tall spikes on the right in the LIDAR data are trees.**

Figure 11 is the LIDAR and survey comparison profile. The LIDAR showed both banks to have 3-foot- to 5-foot-high sections at or near the 27° maximum slope that our reference vehicles were capable of climbing. The site was classified as marginal based upon those measurements. In our on-site surveys we classified the site as unusable because of the slope and bank height with good agreement between the LIDAR and on-site surveys.

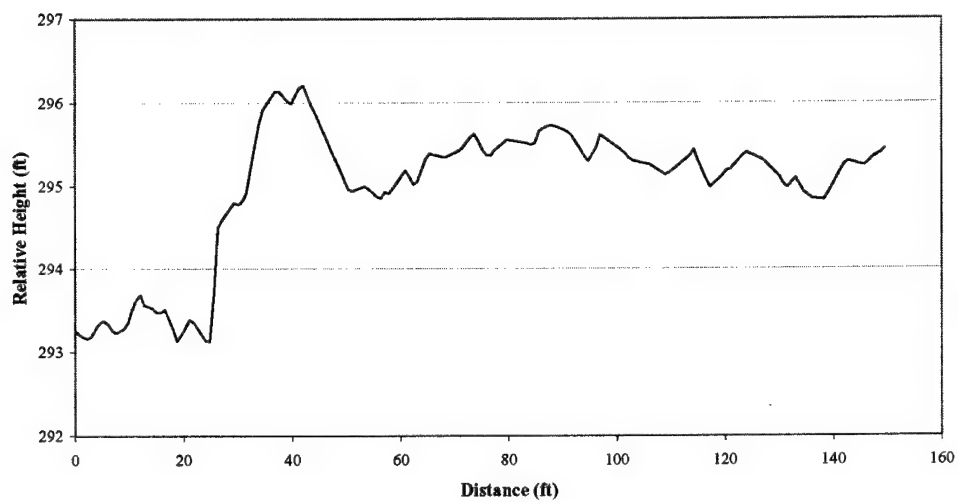
Figure 13. Profile of west bank.

side of the crossing with about a 15-foot-wide swath of tall grass along the immediate top of the bank. This row of grass showed up as a higher feature on the top of the bank. Figure 13 shows a profile of the west bank LIDAR data illustrating the effect. Referring to the horizontal distances in Figure 13, the water surface is from 0 to about 26 feet. The bank starts there and continues to about 31 feet, where the taller grass starts and continues to about 45 feet, which is the approximate beginning of the mown field. This mown field surface indicates the true top of the bank that results in a relative height from the water surface of about two feet, well within our acceptable bank height.

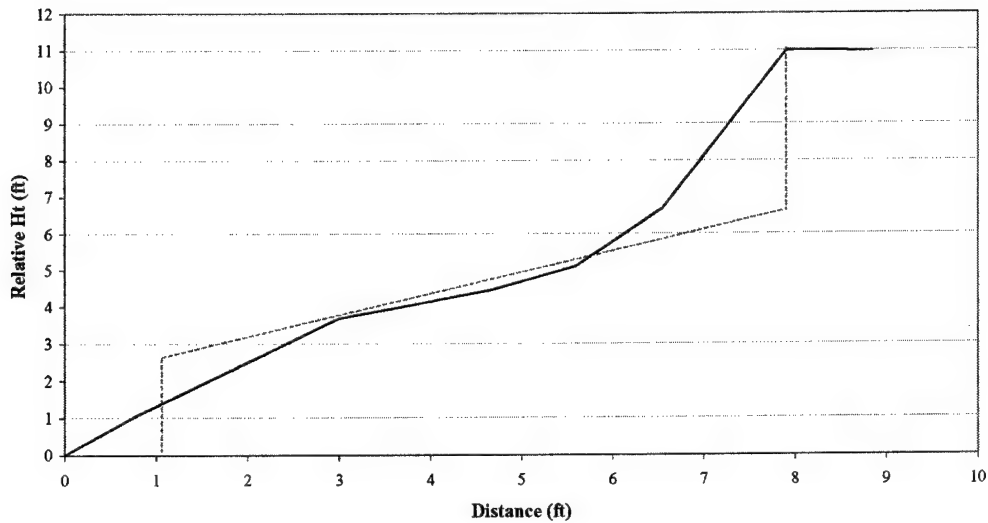
**Figure 14. Site 4 east bank comparing ALSM data (solid line) with approximated measured bank profile (dashed line).**

As mentioned earlier a potential problem with the LIDAR imagery is the difficulty in defining vertical or near-vertical surfaces. Some of this effect was shown in a section of the east bank at Site 2 and another example can be seen in the data from Site 4. During the on-site surveys the sections of the bank were measured as approximately 11 feet high with sections of the face at 90° as shown by the dashed line in Figure 14.

The LIDAR data seem to have smoothed the lower vertical surface into a slope of  $50^\circ$  and the upper near-vertical surface into a slope of  $72^\circ$ . Some of this variation may be due to the difficulty in picking the exact location in the LIDAR data that corresponds to the measured on-site location. The same effect can be seen on the vertical sides of buildings where there is less uncertainty.

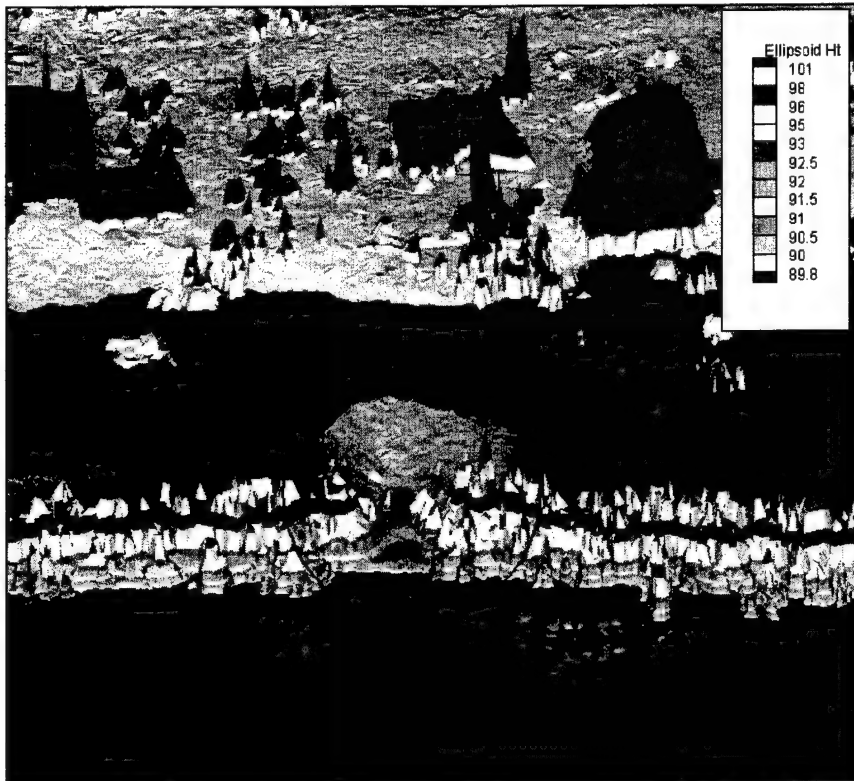
Figure 15. Site 5 east bank DEM showing road leading into the river. Buildings are in the background.

Site 5 was chosen by the terrain team in part because of the presence of a trail on the east bank leading into the water. This feature is circled in the LIDAR DEM as shown in Figure 15. Once in the DEM a cross section can be plotted as shown in Figure 16, and a centerline slope can be calculated for the road from the water up, which, in this case was  $22^\circ$ .

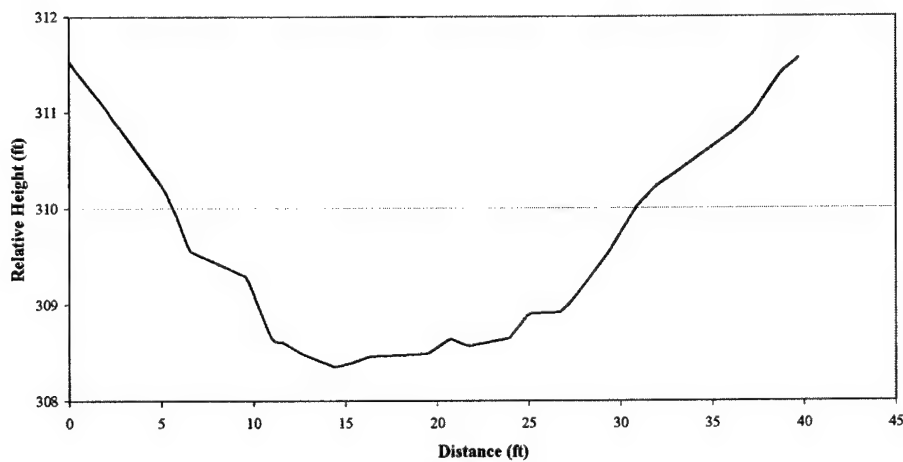
Figure 16. Cross section of road at Site 5.

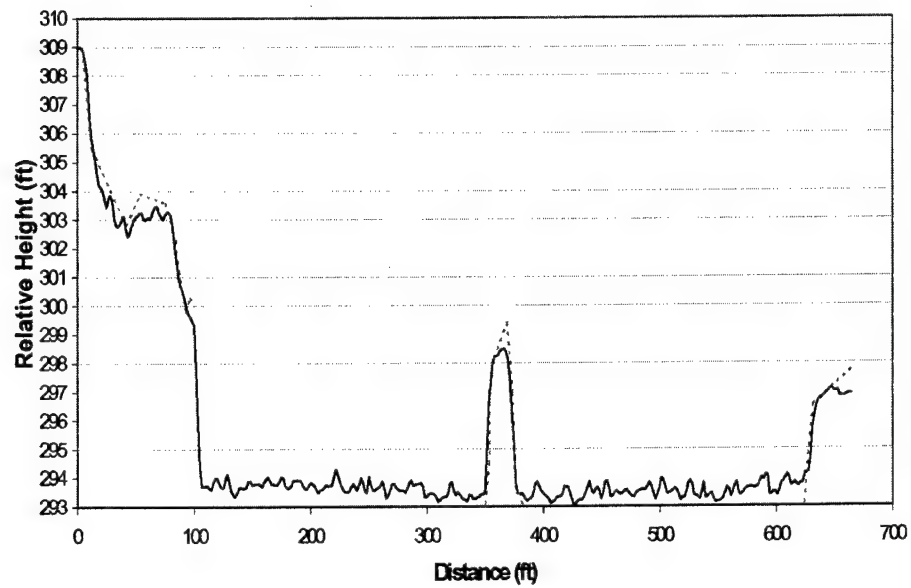
In the three ground survey comparisons below, the east bank is on the left side of the graph.

Figure A2. Site 1, Transect 1, through island. Water surface is from about distance 110 to 350, then from 390 to 620. The island is 350 to 390.

For each site the LIDAR ALSM is shown, as well as graphs for available ground survey comparisons. In the comparisons, the solid blue line is the profile obtained from the LIDAR data and the red dashed line is the ground survey comparison.

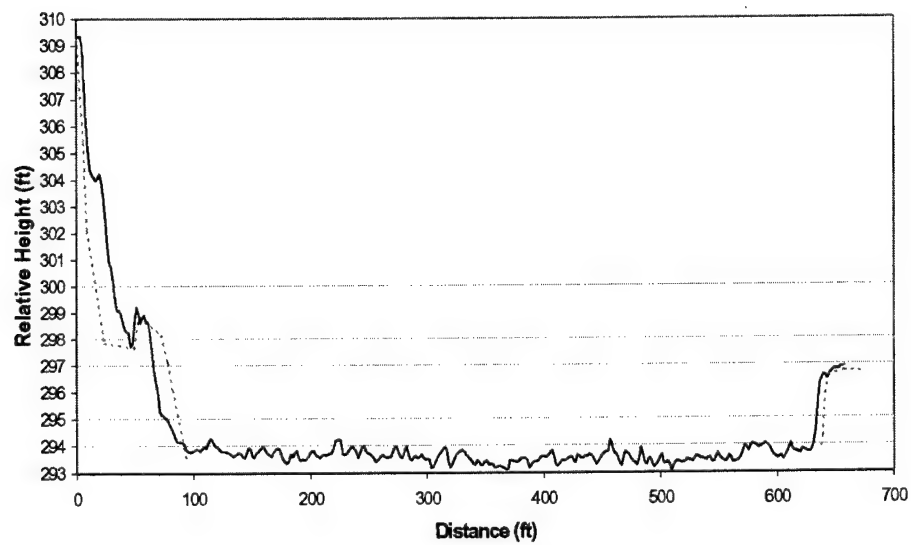
Figure A3. Transect 2. The water surface is from about distance 100 to 630.

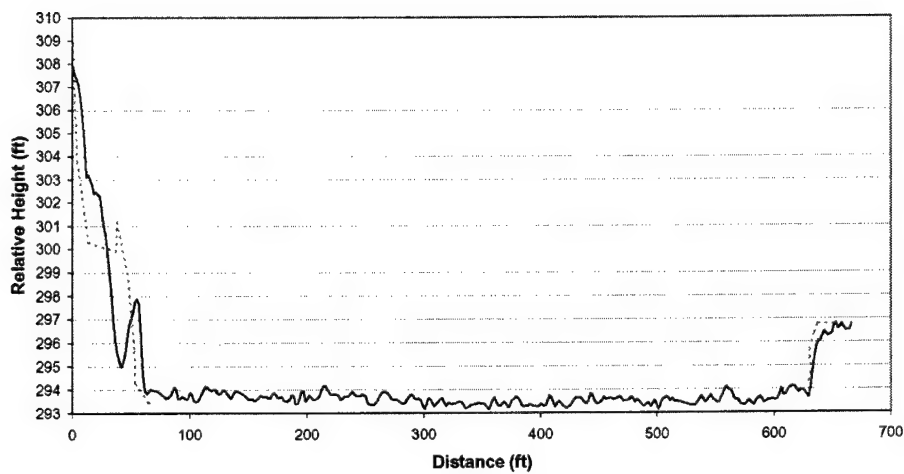
Figure A4. Transect 3. The water surface is from about 80 to 630 feet.

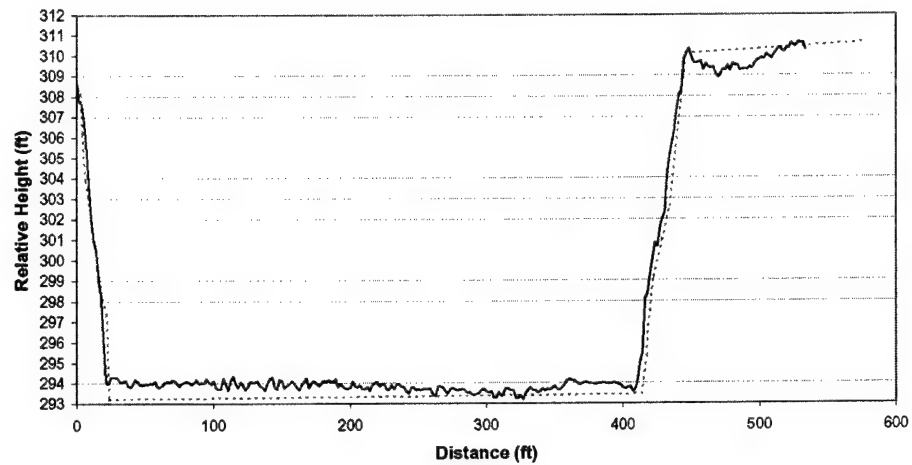
**Figure A6. Site 2, Transect 1. Water surface is from about distance 18 to 400 feet.**

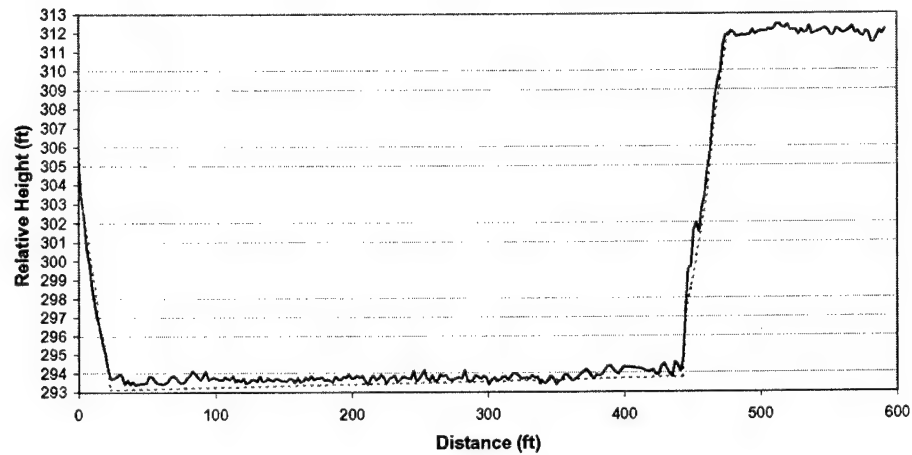
**Figure A7. Site 2, Transect 2. Water surface is about distance 25 to 440 feet.**

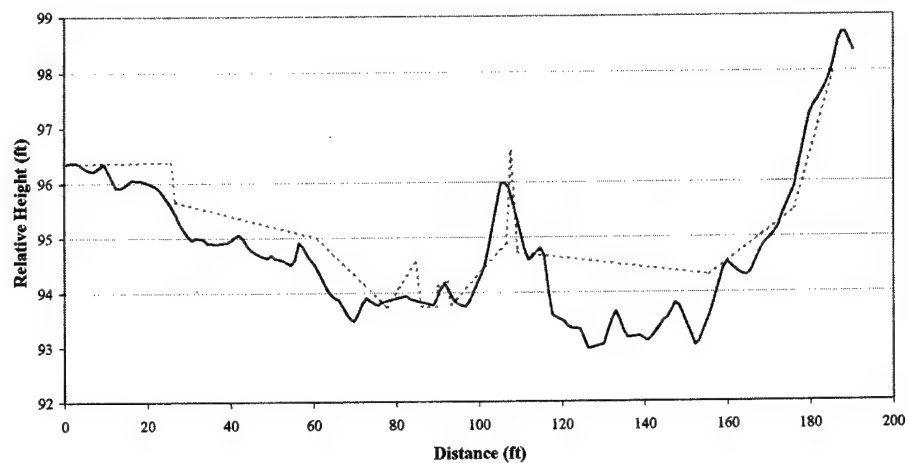
**Figure A9. Site 3, Transect 1 ALSM and survey comparison from the south bank (foreground of ALSM image) to the island in left bottom of the ALSM data.**

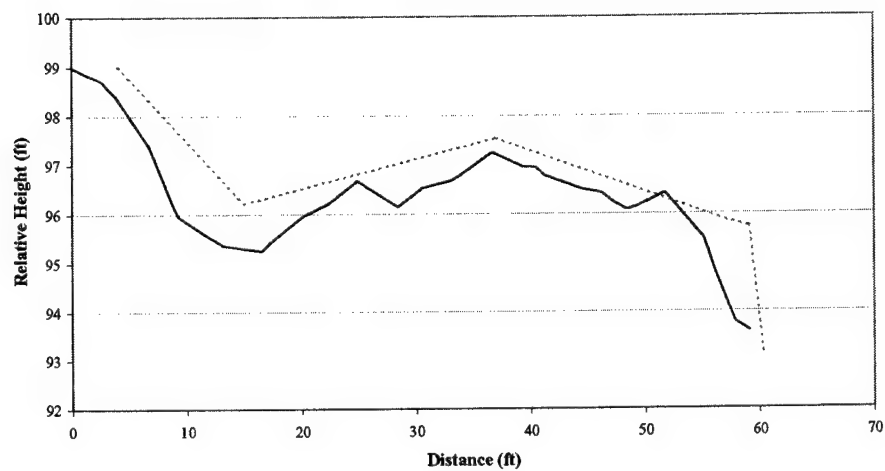
**Figure A10. Site 3, Transect 2 from south bank to water.**

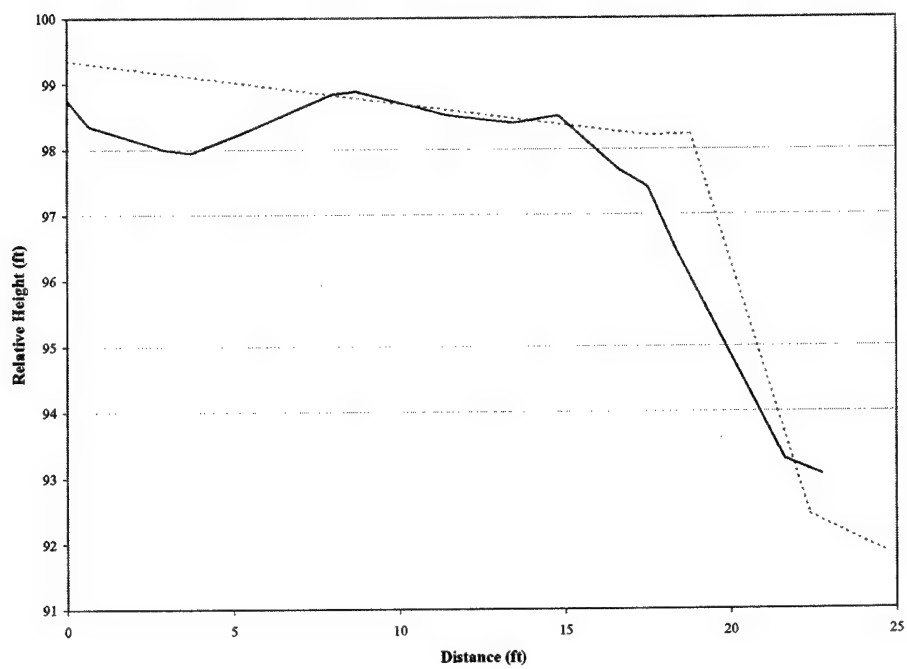
Figure A11. Site 3, Transect 3 from south bank to water.

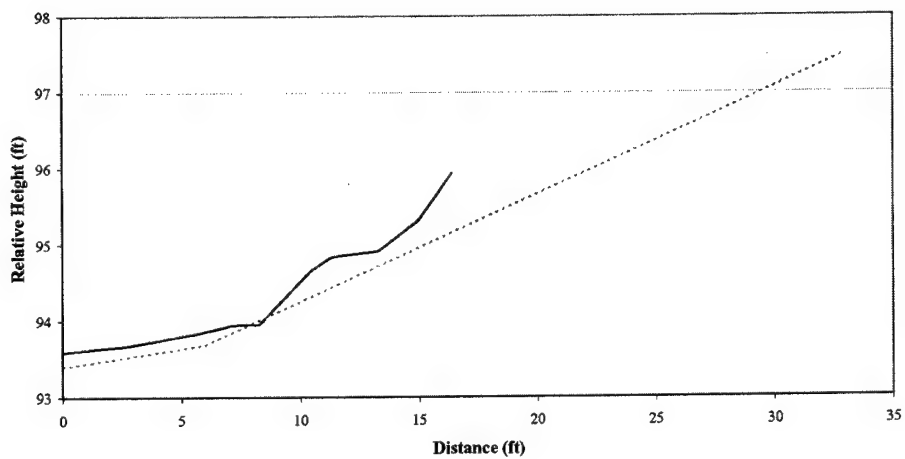
Figure A12. Site 3, Transect 4, north bank. Water surface is a distance 0.

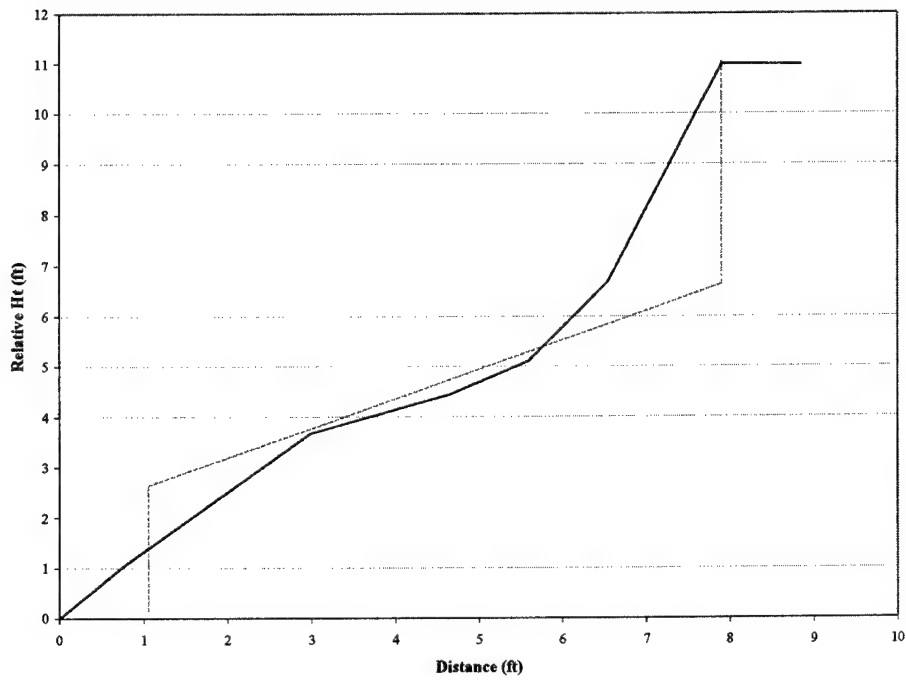
Figure A14. Site 4 east bank ALSM and approximated measured slope.

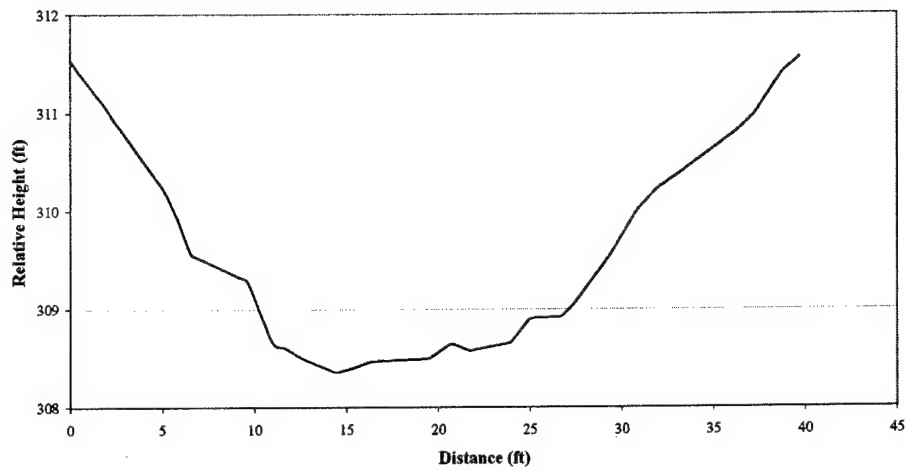
**Figure A16. Site 5 road cross section from north to south. No ground survey available.**

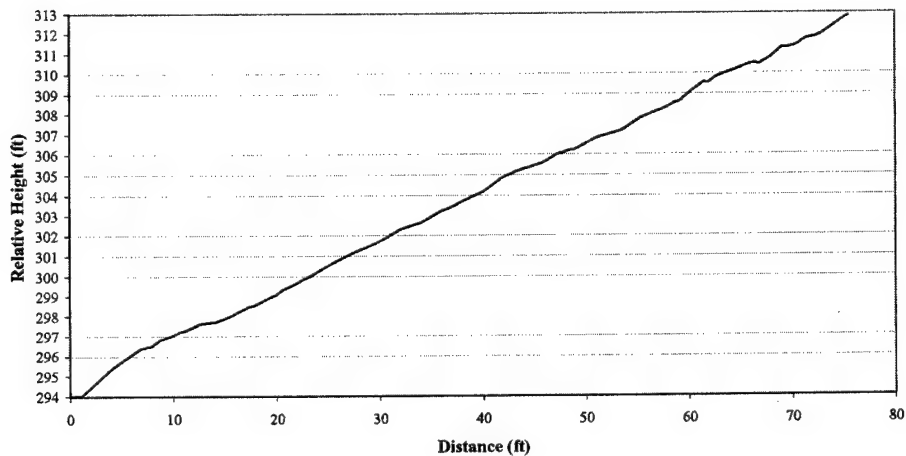
**Figure A17. Site 5 road centerline slope from water surface up. No ground survey available.**

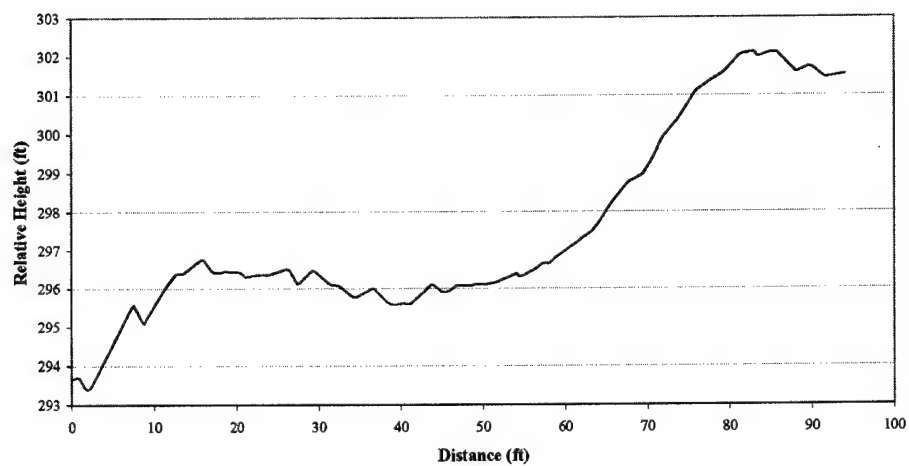
Figure A19. Site 6 east bank ALSM with water surface at distance 0. No ground survey available.

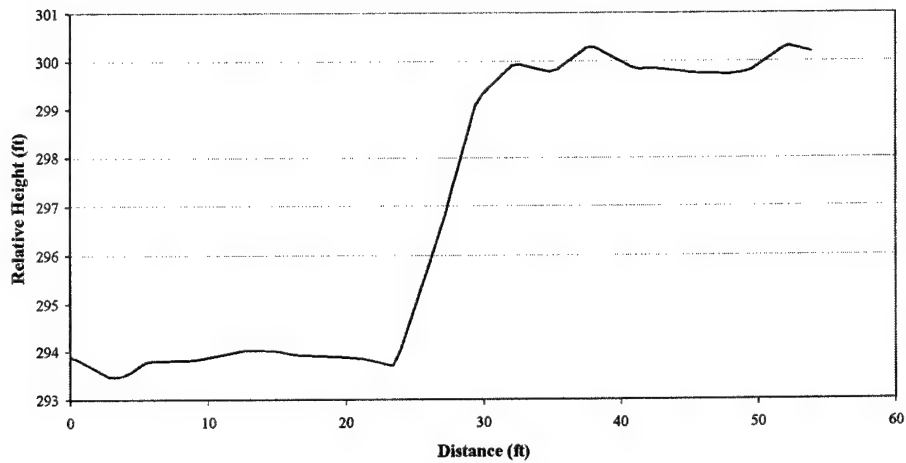
Figure A20. Site 6 west bank ALSM with water surface from distance 0 to 25 feet. No ground survey available.

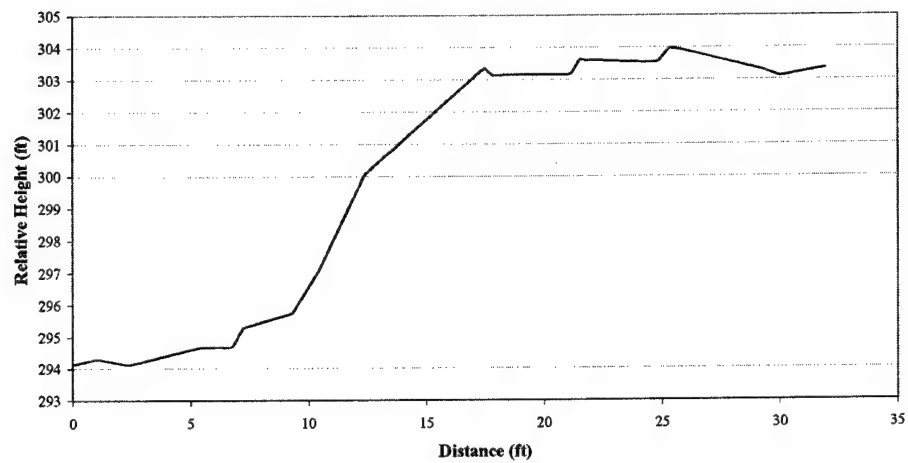
Figure A22. Site 7 east bank ALSM with water surface from about distance 0 to 7 feet. No ground survey data available.

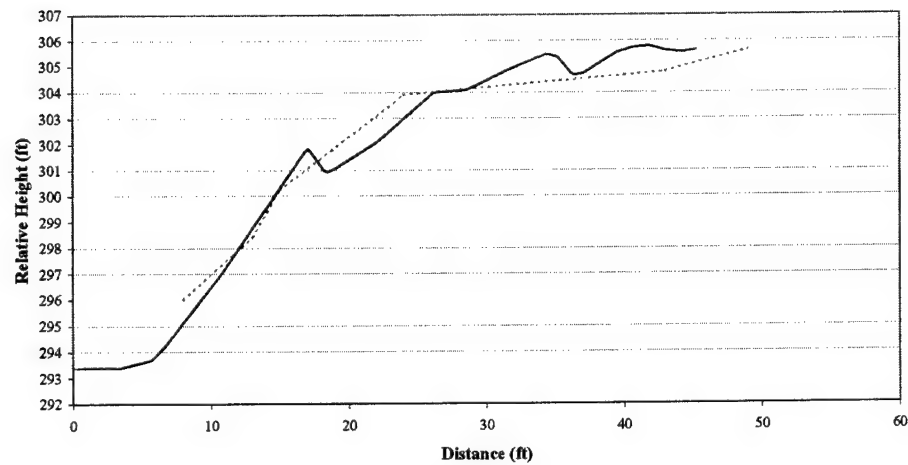
Figure A23. Site 7 west bank ALSM and ground survey comparison. Water surface is from distance 0 to about 5 feet.

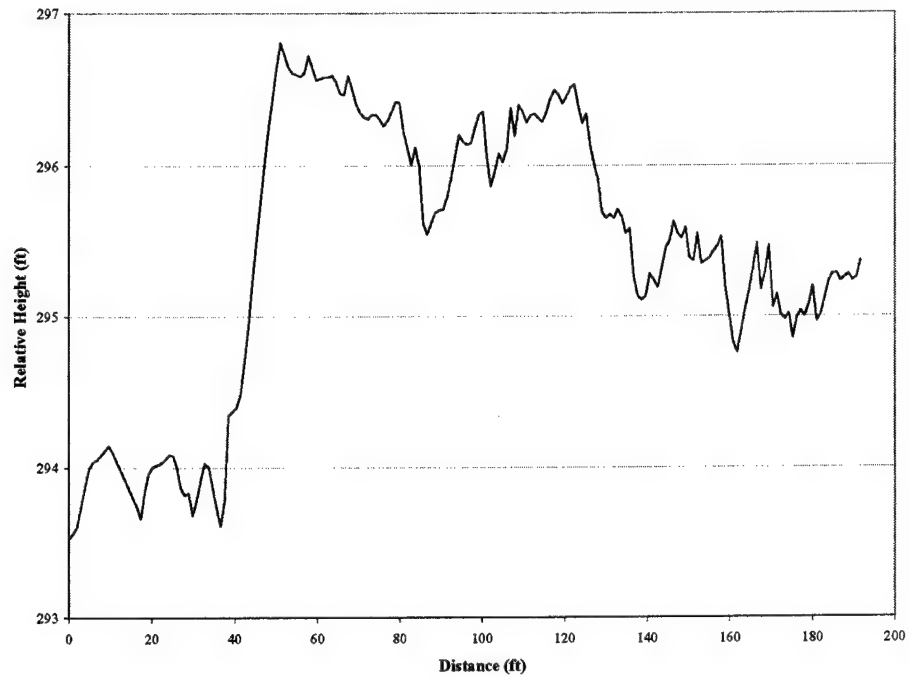
**Figure A25. Site 8, east bank ALSM, a low marshy area with marsh grass. Water surface is from distance 0 to about 35 feet. No ground survey data available.**

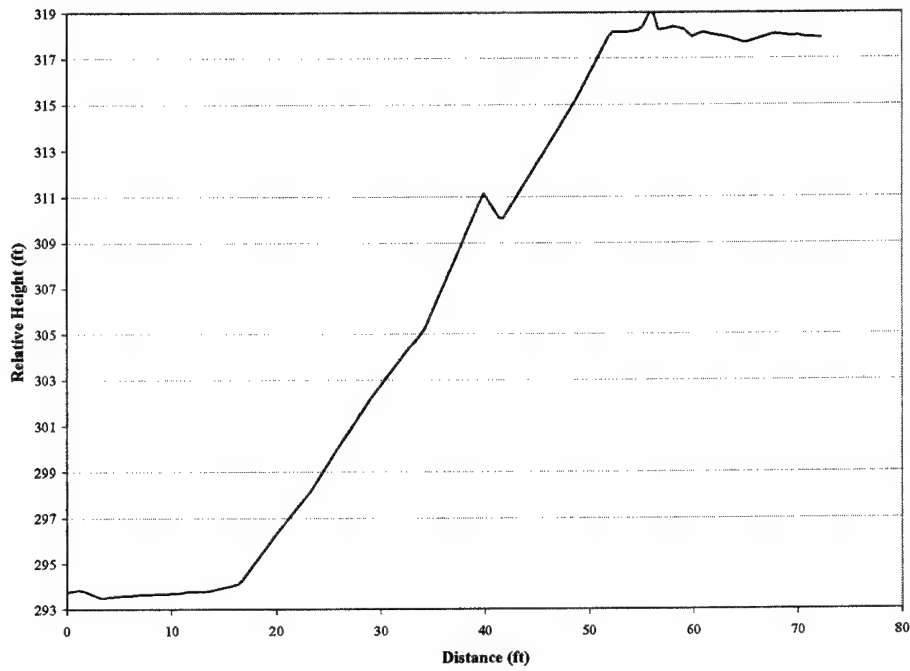
**Figure A26. Site 8 west bank. Water surface is from distance 0 to about 15 feet. No ground survey data available.**

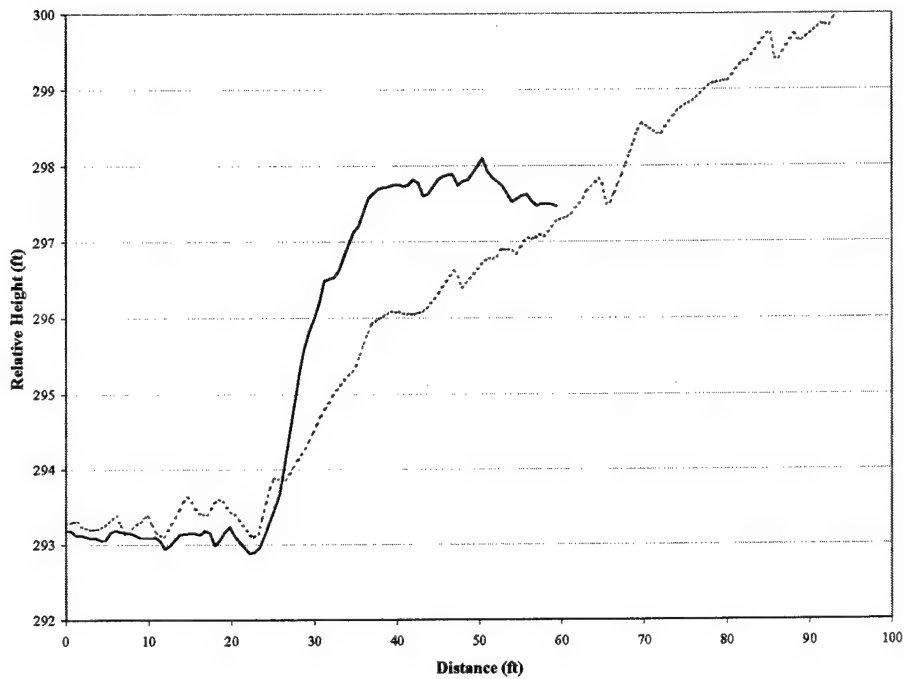
**Figure A28. Site 9 east bank. Water surface is from 0 to approximately 23 feet. Dashed blue line is bank slope at a boat launching area. Black solid line is slope at another portion of the bank for comparison. No ground survey data available.**

Following are the three sites classified as marginal from the LIDAR survey. The first two examples from Site 2 and Site 20 were found to be marginal because of bank slope measurements and/or height. The last example, at Site 9, was apparently because LIDAR returns from tall grass along the bank made the bank appear higher than it was.

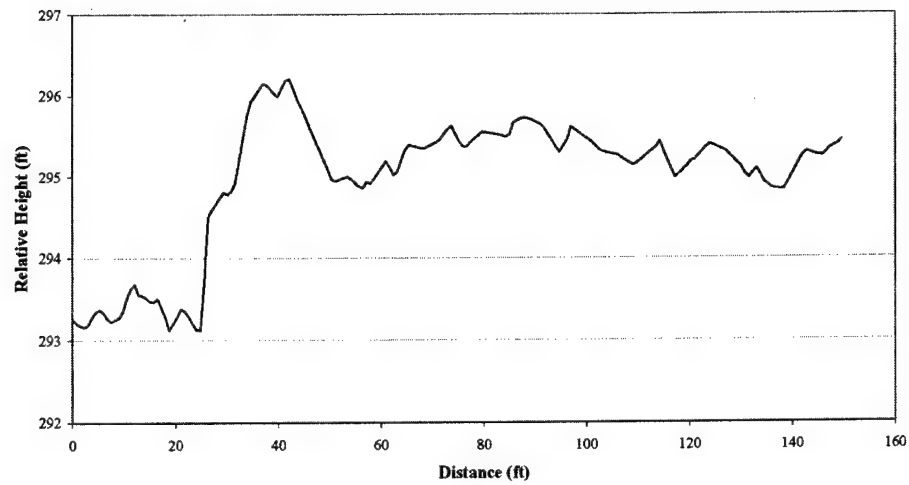
**Figure A29.** Site 9 west bank. Water is from distance 0 to about 22 feet. First peak after that is thought to be bank with thick grass taller than a mown field from about 50 feet onward. No ground survey data available.

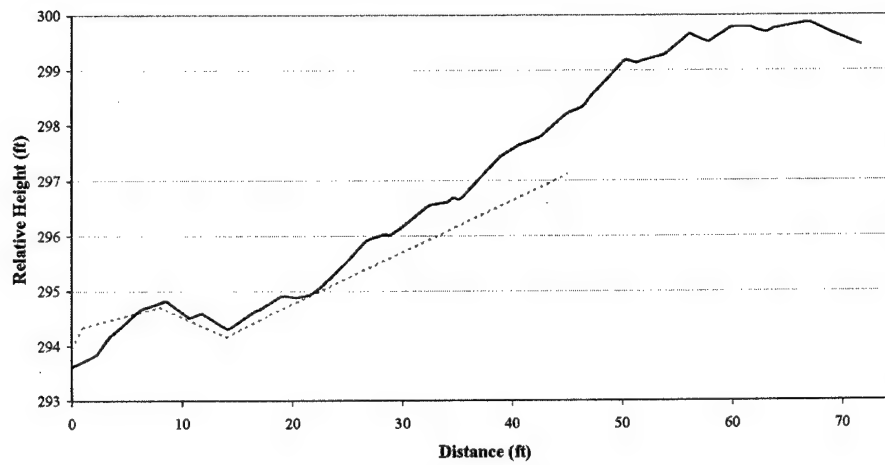
**Figure A31. Site 10 east bank survey and ALSM comparison. Water surface is at distance 0.**

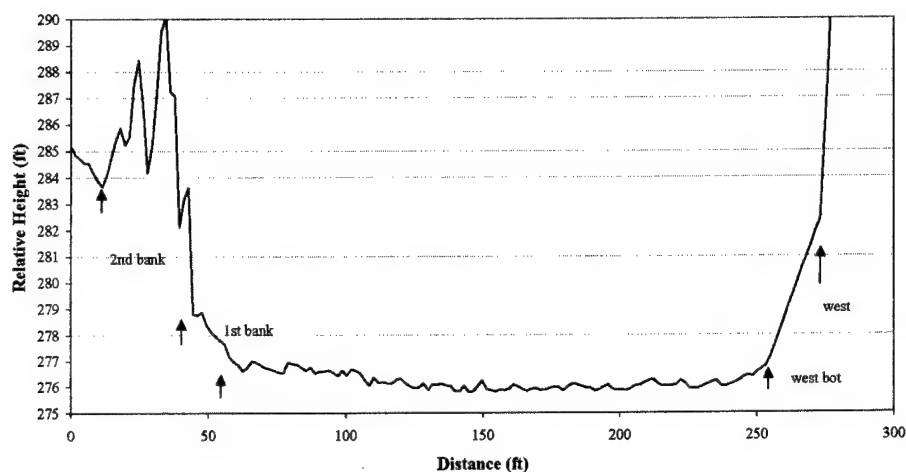
**Figure A33. Site 13 ALSM profile. Distance 0 is at the east bank. The jagged profile between the first and second east side banks are vegetation. The water surface is from about distance 65 to 250 feet.**

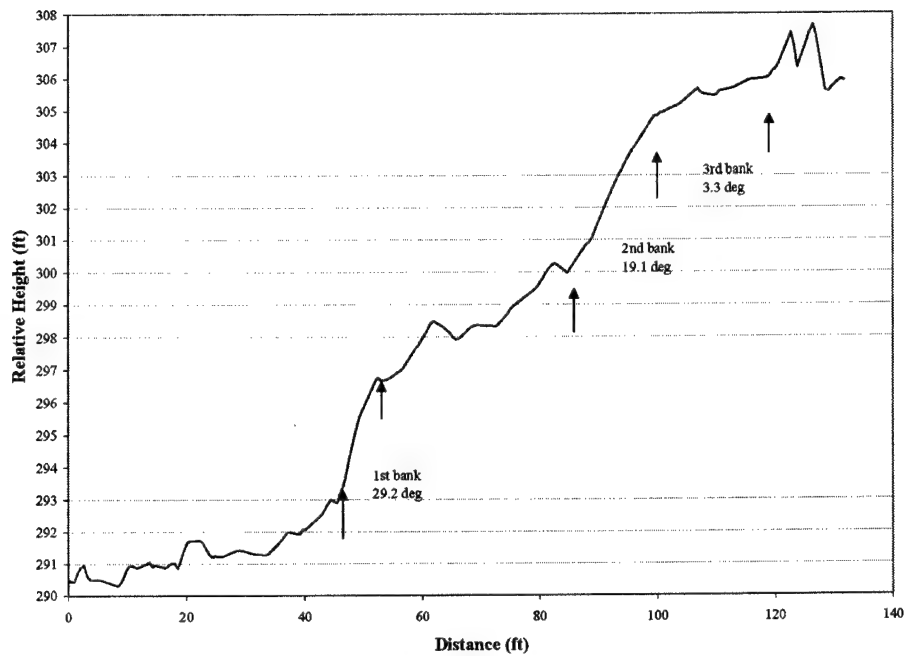
Figure A35. Site 14 east bank. Water surface is from distance 0 to 35 feet. No ground survey data available.

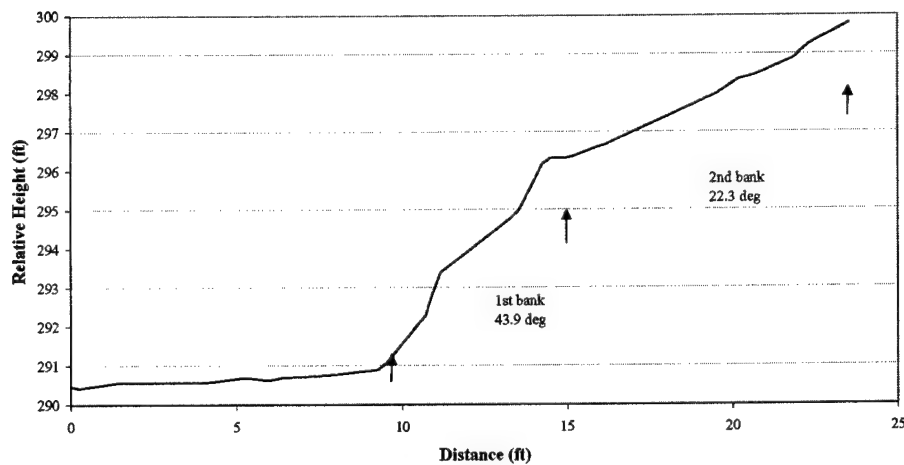
Figure A36. Site 14 west bank. Water surface is from distance 0 to about 7 feet.

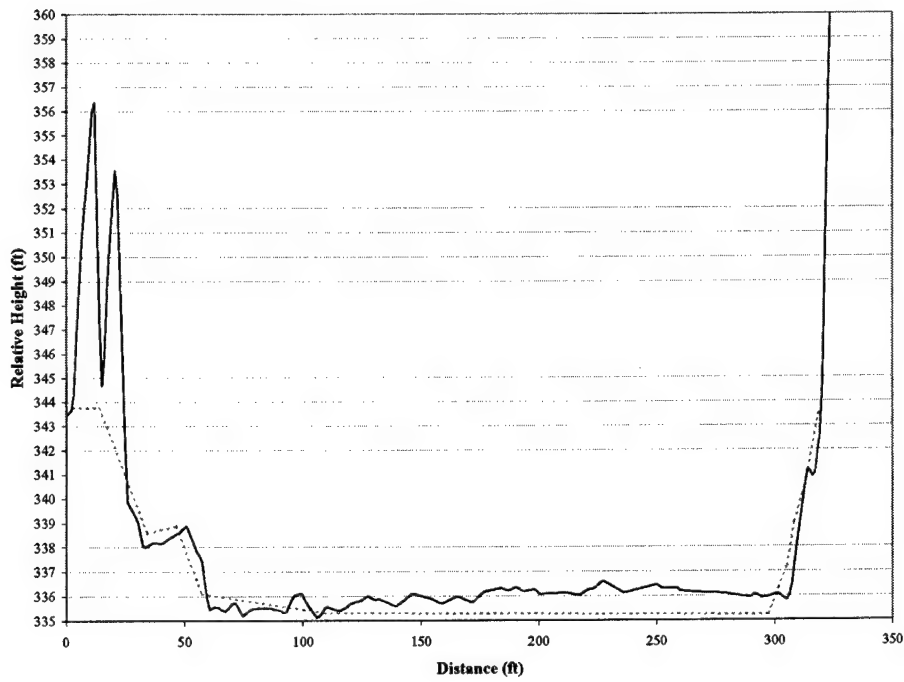
**Figure A38. Site 15 ALSM and survey profile comparison. Distance 0 is on the east bank. Water surface is from about distance 70 to 300 feet.**

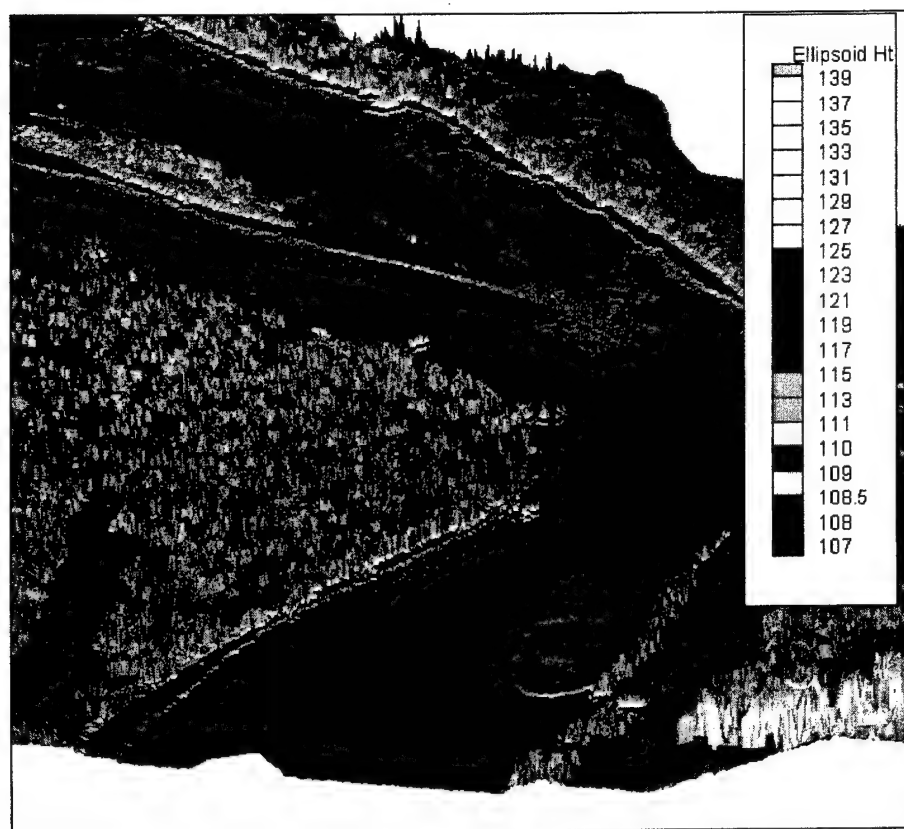
Figure A39. Site 16 ALSM looking north. Area on the west bank with clearings evident was discussed in text of report for trail recognition.

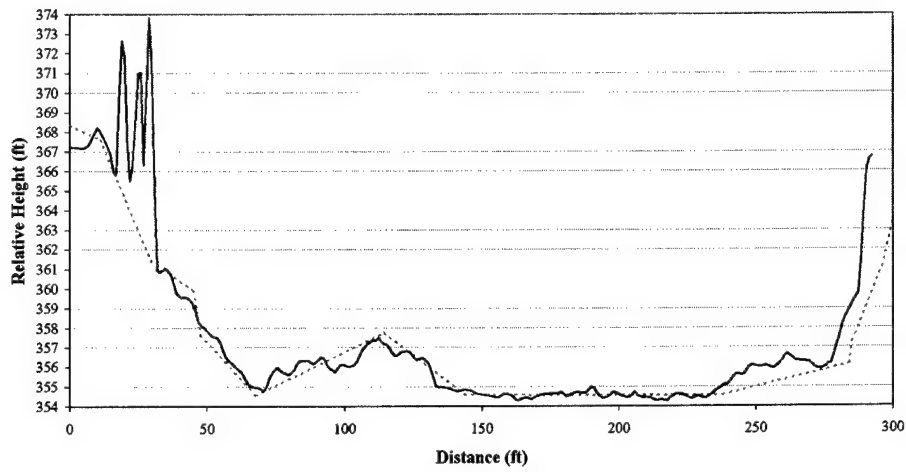
**Figure A40. Site 16 ALSM and survey comparison. Distance 0 is on the east bank.**

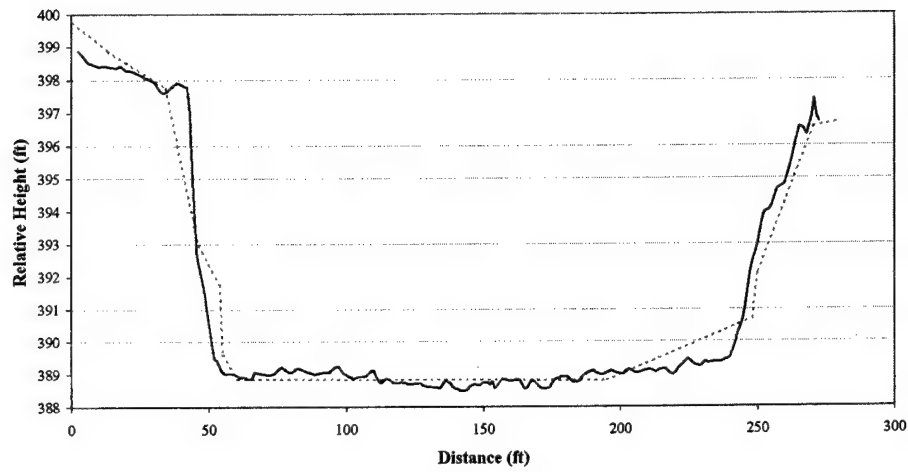
**Figure A42. Site 17 ALSM and survey comparison. Distance 0 is on the east bank. The water surface is from about distance 55 to 200 feet.**

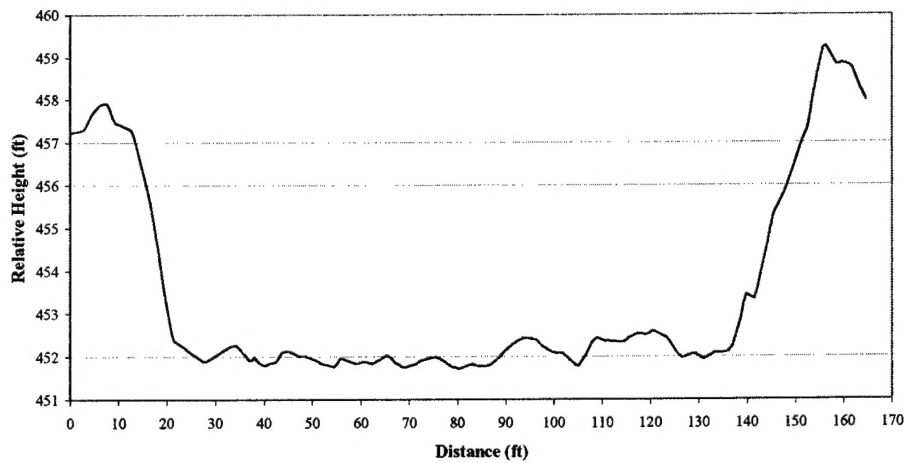
**Figure A44. Site 18. Distance 0 is on the north bank. The water is from about distance 30 to 135 feet. No ground survey data available.**
